**The Great Salt Lake Causeway-  
Its Recent History and Current Maintenance Program**

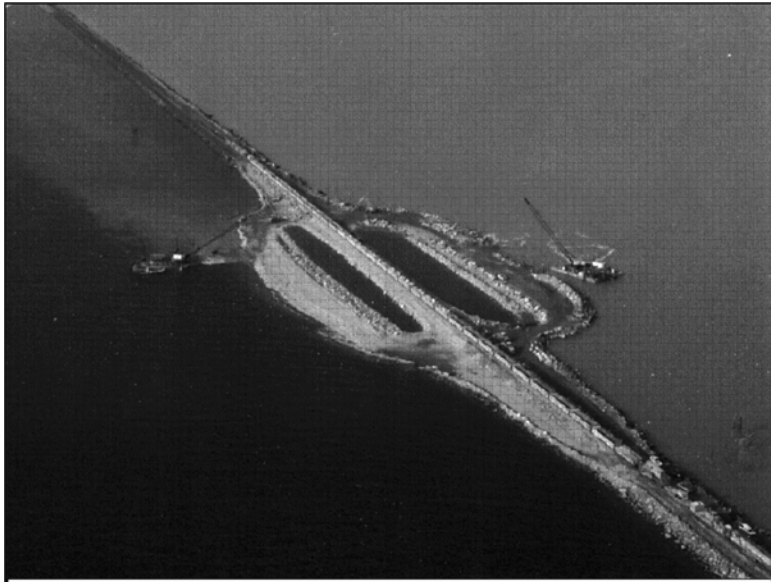
Figure 5- MP748 Final Berm Configuration

In early 1999, the area around MP748 was settling approximately nine inches per month and was being leveled regularly by the local surfacing crew. On 16 August 2000, a 1000-foot long section of the embankment at MP748 dropped 10 feet overnight. The UPRR was able to raise the track level four feet in one day to keep it above the water level, but over the next night, the track dropped down to water level again. The UPRR requested assistance from MPA, who identified the problem as a bearing capacity/lateral spreading failure.

After completion of the berms, MPA drilled three borings in the area to ascertain the cause of the failure. Based on the results of the borings, it appears that the salt layer, which was identified in the original design drawings of 1956 and in the borings from the early 1980's, is no longer present. It is suspected that the salt layer dissolved, which contributed to the failure, or broke into many pieces as a result of the failure. The actual failure mechanism is not fully understood at this time.

**Fig 5: MP748 Final Berm Configuration**

While the short-term solution of keeping the trains running across the GSL was accomplished, a permanent solution to stabilize this portion of the Causeway was being designed and sent out to bid. The solution consisted of constructing two massive, rock-filled berms, one north and one south of the failure area, to prevent additional movement. The construction of the berms began

on 12 Sept 2000 and was completed in late January 2001. The railroad partnered with the contractor to complete the work. The fill to construct the berms was delivered by two side dump car work trains, consisting of thirty cars each that came to the site twice per day, with two deliveries in the morning and two in the afternoon. Draglines, located on barges on each side of the causeway, spread the material out over the soft bottom sediments and excavators placed the armor rock on the outer edge of the berms for wave protection. Figure 5 is a photo of the final berm configuration.

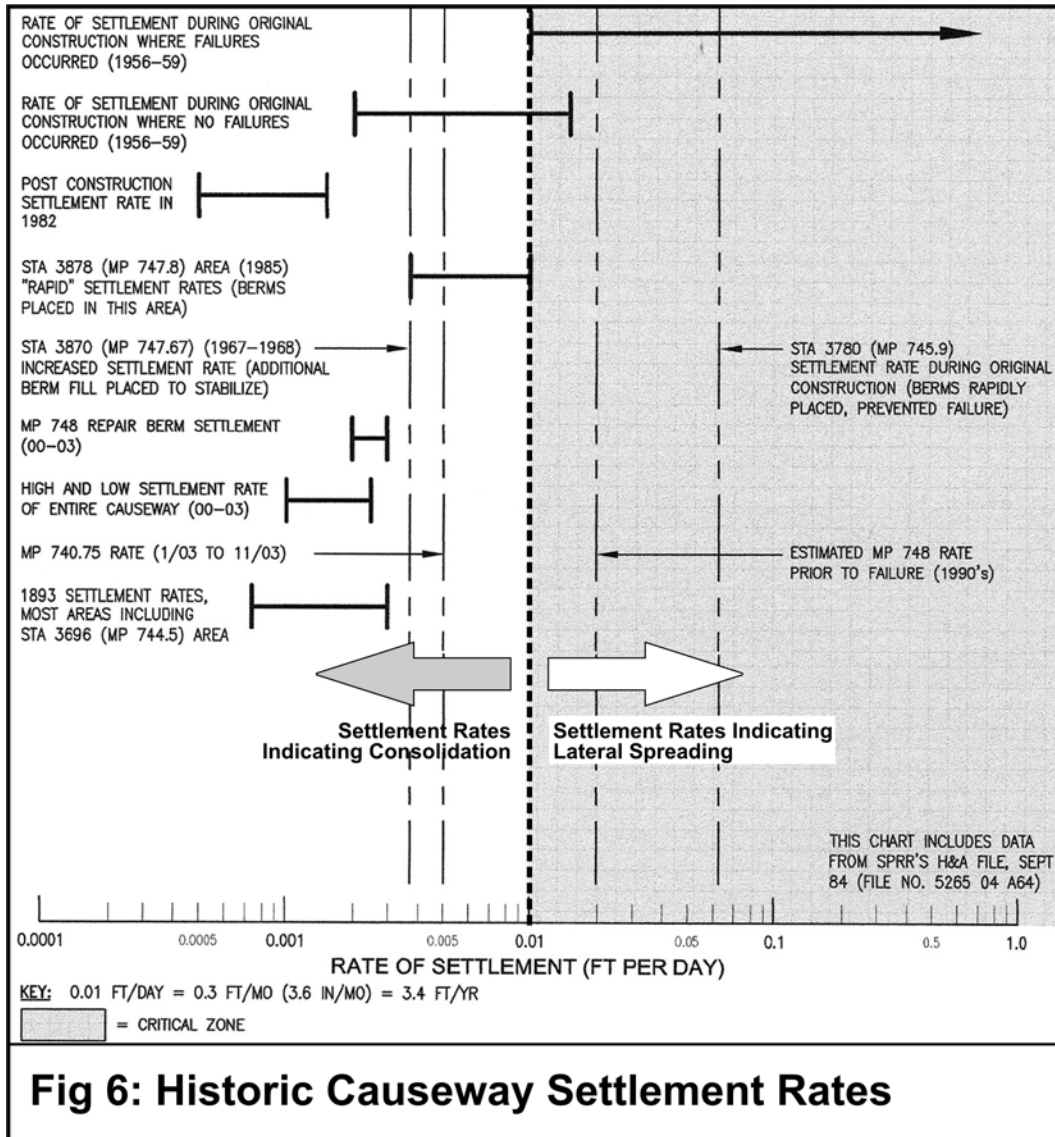
Figure 6- Historic Causeway Settlement Rates

Figure 6 is a compilation of historical settlement rates since the time of construction in the 1950's, showing the settlement rates which were known to produce failure of the embankment and those that didn't. If the rate is below 0.01 feet per day, or 3.4 feet per year, this settlement is considered consolidation. However, if the rate is greater than 0.01 feet per day, this is considered lateral movement, which could progress to an embankment failure. Counterweight berms, similar to those at MP748, would need to be constructed to reduce the lateral movement. The railroad is prepared to mobilize rapidly to construct these berms, if necessary.
