Raw Water Tunnel Condition Assessment

ABSTRACT: As part of its risk management plan, the South Central Connecticut Regional Water Authority (RWA) is assessing the condition of its system of raw water conveyance tunnels and connecting pipelines. In 2006, the RWA inspected one of the system's main tunnels, a 4-mi, 1950s-era tunnel that had not been inspected since its construction. The inspection team prepared extensively for the unknown conditions in the tunnel, and the inspection was completed safely and successfully. This paper describes the team's pre-entry preparations, dewatering and ventilation efforts, surface-to-tunnel communication, access, physical inspection of the tunnel, and the lessons learned throughout the process. Additionally, this paper will preview planning for the subsequent inspections.

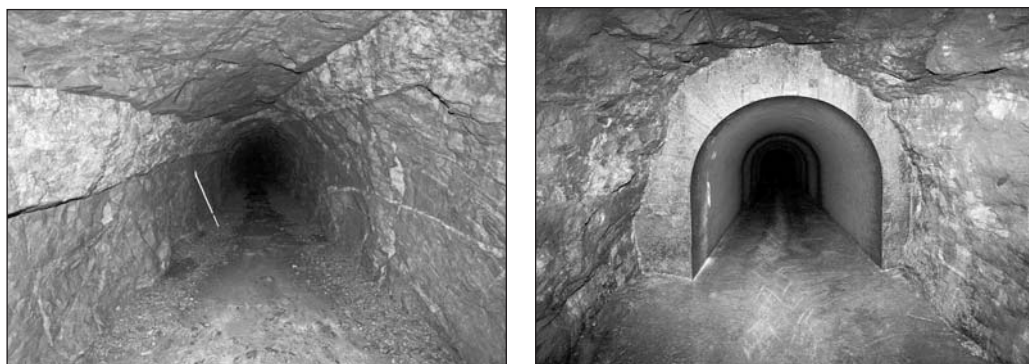
Figure 3. Typical photographs of the unlined and lined sections of Tunnel No. 1. Note the prominent pegmatite dike cutting the gneiss foliation.

Monson Gneiss. Both units consist predominantly of quartz biotite gneiss and amphibolite. The tunnel was constructed by drill-and-blast methodology. The as-built construction records of the tunnel, which were confirmed by the inspection, indicate that the tunnel is 41% unlined and 59% lined with cast-in-place concrete. The lining was placed in areas of adverse rock conditions where long-term stability of the tunnel opening was considered uncertain or where groundwater inflows were excessive. Photographs of the unlined and lined tunnel are provided in Figure 3.

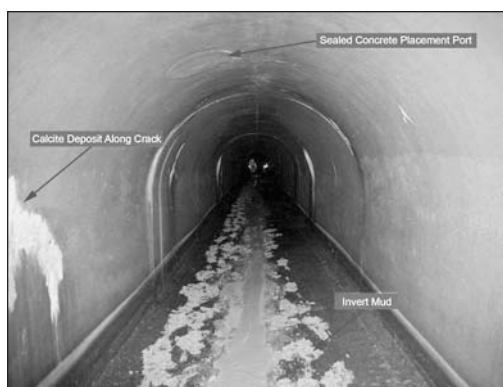
It appears that the sluice gates at the Intake Structure were opened quickly over the years. The fast in-rush of water that this created has, over time, eroded the invert of the upstream unlined section of tunnel. The sand and gravel fill normally found in the tunnel invert has been transported downstream to around Sta. 178+00, which is just upstream of where the tunnel remains filled with water.

Figure 6. The portion of the tunnel above the “stored” water level lined with mud in the invert, which made walking difficult

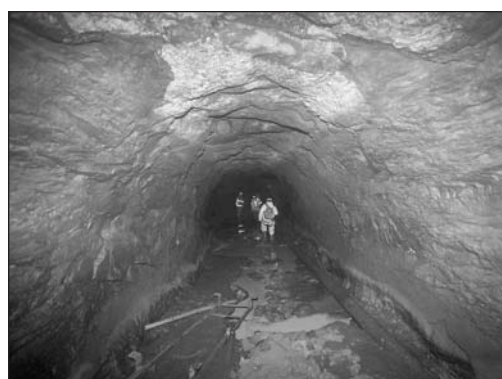
- Walking down grade (in the direction of flowing water) is generally easier for an inspection team. However, in this tunnel the inspection team found it was easier to walk up grade, due to the excessively slippery floor surface caused by the organic growth. In addition, there were no significant groundwater inflows that could make walking up grade and against flowing water more difficult. The upper portion of the tunnel invert near the Intake Structure was covered with a thin layer of mud (see Figure 6). Walking down grade with the mud on the first day was more difficult than walking up grade on the second day. The difference was most noticeable in the upstream unlined sections near the Intake Structure, where the invert was uneven and coated in mud (see Figure 7).

Figure 7. The first unlined tunnel also showed residual mud in the invert, which made walking difficult. Note the remnants of the one of the ladders from the intake structure.
