# **Underground Construction for a Combined Sewer Overflow System in Providence, Rhode Island**

**John L. Kaplin**  
Gilbane

**Jeffrey P. Peterson**  
Jacobs Associates

**Philip H. Albert**  
Narragansett Bay Commission

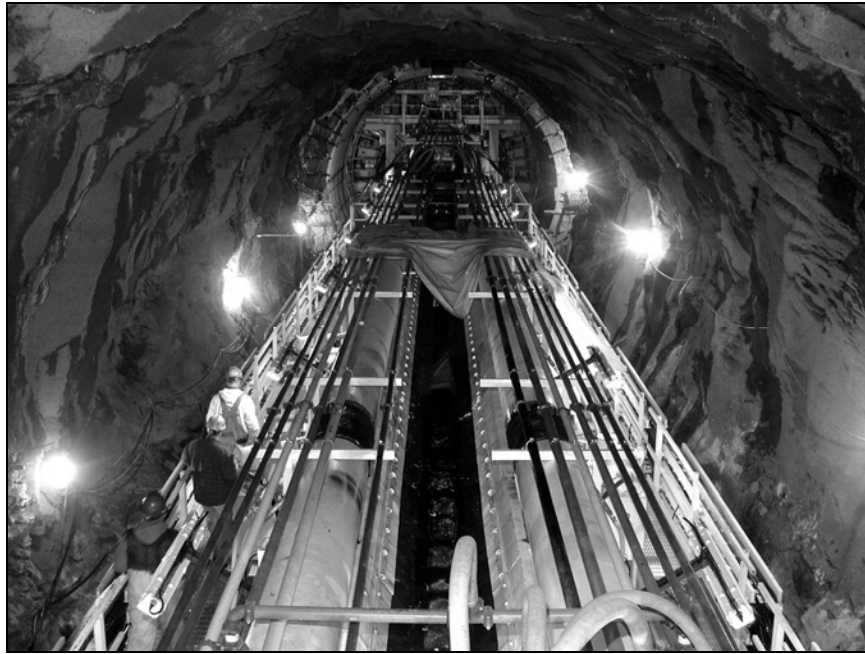
FIGURE 2. TBM in starter tunnel.

The TBM was launched from a starter tunnel at the S-1 shaft on March 8, 2004 (Figure 2). Within a month, production was in the 12.2 to 13.7 m/day (40 to 45 ft/day) range. Mining was performed on one long shift, from 6:30 a.m. to 6 p.m., with maintenance performed on the back shifts. The basic mining cycle consisted of mining through 1.2 m (4 ft) of rock in 25 to 40 min, separated by time to install segments and wait for trains. Haulage by rail was performed by three locomotives hauling five muck cars and one segment car. Two rail switches were used—a fixed one at the S-1 shaft and a second, forward one that was periodically advanced toward the heading to improve rail transit. A muck car roll-over dump, a vertical conveyor in the shaft, and a radial stacking

The cutterhead was 9.1 m (30 ft) in diameter and equipped with 65 43-cm (17-in.) diameter, back-loading cutters. The machine employed 20 jacks to propel and steer off precast segments, with a total available thrust of 28,024 kN (6,300,000 lb). The cutterhead was rotated at 3 to 5 rpm and was driven by 20 hydraulic motors rated at a total of 1,837 kW (2,465 hp). Power for the thrust, head rotation, conveyors, and segment erection was electric over hydraulic.

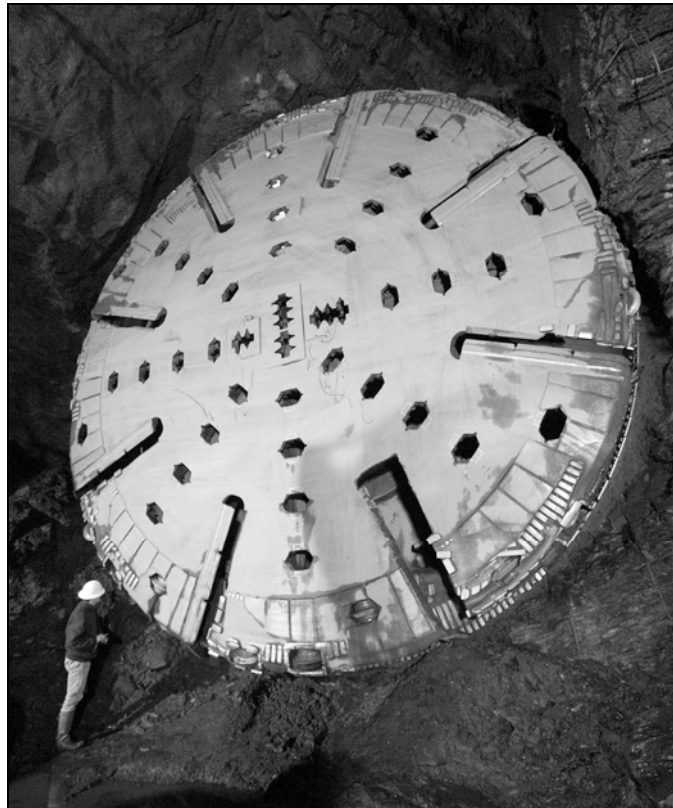
FIGURE 3. TBM cutterhead following hole-through at the Foundry shaft (photo by Sue Bednarz).

None of this should overshadow the overall performance of the TBM, which operated with a high degree of reliability and made steady progress. The TBM holed through at the Foundry shaft in early December 2005 (Figure 3). Production on the single long shift, five days a week, yielded 274–427 m (900–1,400 ft) per month, with a daily production between 12.2 m and 18.3 m (40 ft and 60 ft) per mining day. Table 3 provides a summary of performance data for the TBM. One

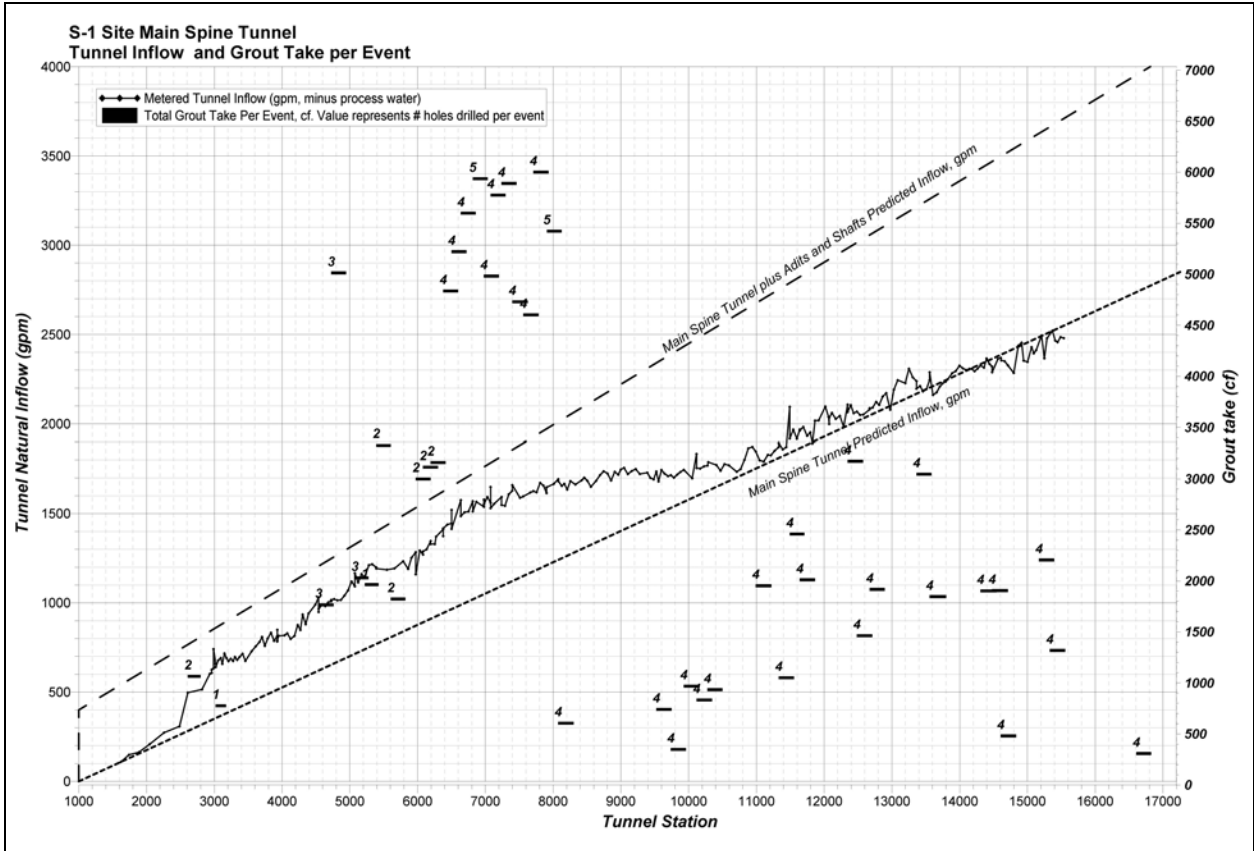
FIGURE 4. Water inflow and grout take per event in the Main Spine Tunnel.

During the early stages of mining, inflow into the tunnel increased at a greater rate than anticipated, despite the use of the pre-excavation grouting program. By the time 25% of the MST had been mined, the inflow already had reached 4,540 Lpm (1,200 gpm), or 36% of the total anticipated inflow. For this reason, the grouting program was modified a number of times, and it is worth noting the more significant changes to the program based on conditions encountered. A summary is shown in Table 4. Figure 4 is a graphic of the inflow and the grout-event history.

| TABLE 4. Pre-excavation Grouting Program Summary | | | |
|--|--|--|--|
| Grout pressure | 3.5 MPa<br>(500 psi) | 2.4 MPa<br>(350 psi) | At the higher pressures, grout takes were in the range of 142–170 m <sup>3</sup> (5,000–6,000 ft <sup>3</sup> ) per event. It was judged that a considerable portion of the grout was pushed through fractures outside the tunnel envelope, perhaps due to hydrojacking. After the pressure was reduced, grout takes were lowered by a factor of two to four, with no apparent loss in effectiveness, as is visible in Figure 4 from Station 80+00 and beyond. |

There was relatively little decay observed in the inflow rates over time in the MST. This assessment was based on direct measurement of sustained inflows. The overall effectiveness of pre-excitation grouting can therefore be analyzed in rough terms by comparing probe inflow to tunnel inflow in grouted versus ungrouted portions of the tunnel. The results are shown in Table 5.

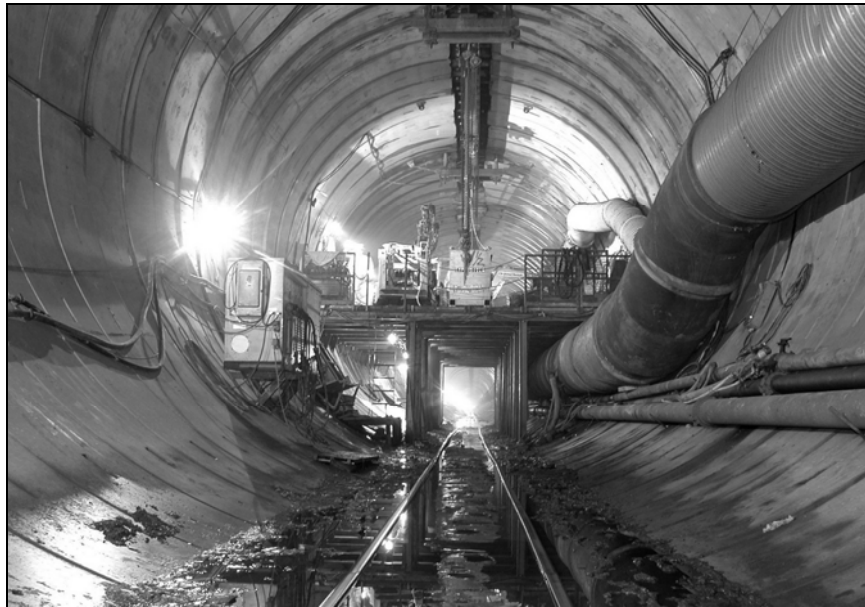
FIGURE 5. Elevated deck for construction of the adit from the Main Spine Tunnel.

Seven adits were excavated off the MST to connect the tunnel to the drop and vent shafts previously installed by other NBC contractors. To mitigate the schedule loss of a year's time that occurred prior to the start of MST mining, all adits were excavated and lined concurrently with the excavation of the MST. The exceptions were the 067 and WRI adits, which were driven from the base of the S-1 and Foundry shafts, respectively. Elevated decks were constructed in the MST at each of the adit portals to service the adit excavation and concrete lining. This allowed access to the adits, which intersected the MST at the spring line while allowing MST train traffic to pass unimpeded beneath the deck (Figure 5).
