# PROBLEMS ENCOUNTERED ON THE UPPER REACH OF THE NORTHEAST INTERCEPTOR SEWER PROJECT

The Upper Reach segment of the Northeast Interceptor Sewer (NEIS) is a 3.2-km-long tunnel excavated in interbedded marine sedimentary deposits with approximately 40 m of cover. The tunnel was initially classified by Cal/OSHA as “potentially gassy.” During excavation, high levels of hydrogen sulfide and methane were encountered, prompting Cal/OSHA to reclassify the tunnel as “gassy.” In addition, the tunnel excavation encountered an abandoned, 100-year-old water tunnel known as the “Narrows Gallery.” This existing tunnel was completely full of water and under 30 m of hydrostatic head. This paper will discuss the unanticipated difficulties and design solutions implemented to construct a gassy tunnel exposed to high volumes of water.

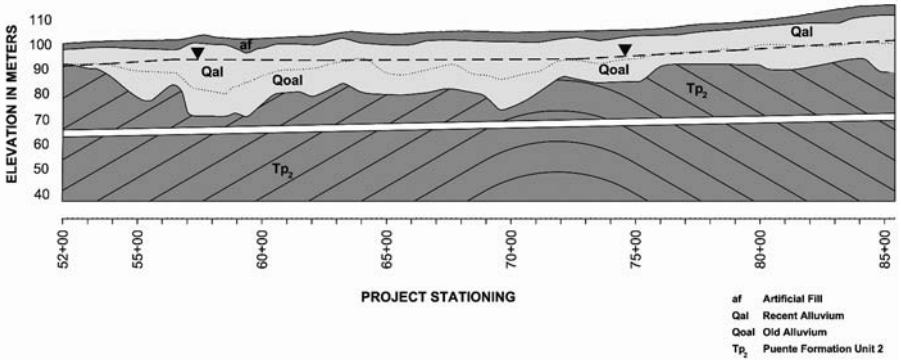
Figure 2. Geologic cross section of upper reach

The design phase borings indicated sedimentary marine deposits along a majority of the Upper Reach alignment with the possibility of encountering overlying alluvial soil deposits in two locations, as shown in Figure 2. The following paragraphs summarize the physical properties of these two formations (*City of Los Angeles 2001*).

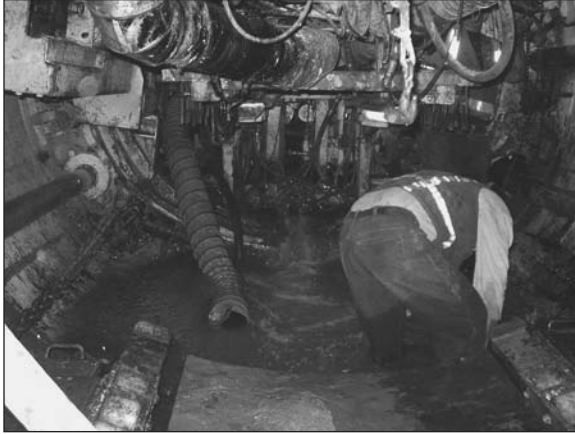
The Narrows Gallery crossed the NEIS alignment at a skewed angle, and the TBM had to advance four strokes to clear the gallery. Even though 32 m<sup>3</sup> of LMG had been placed in the void at this location, on the fourth stroke at 11 p.m. on December 1, 2003, the Narrows Gallery drained into the NEIS tunnel. For the next 2 weeks, TSKF mined less than 4 m per day, working 24 hours per day. Water from the Narrows Gallery followed the TBM, flooding the invert of the tunnel with sand and silt on every advance

Figure 3. Water inflows experienced in heading

of the machine (as shown in Figure 3). The placement of LMG failed to stop the large inflows of water.

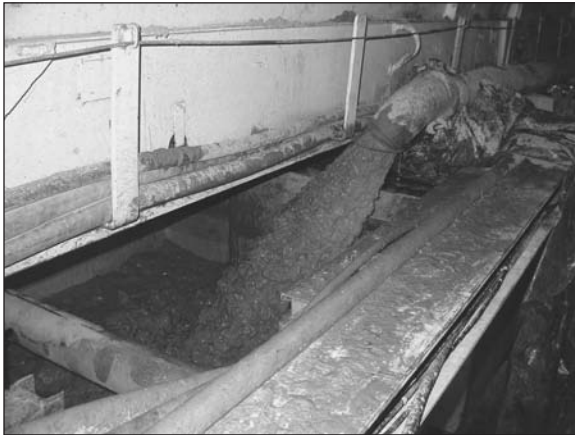
Figure 4. Excavated material discharged into muck cars

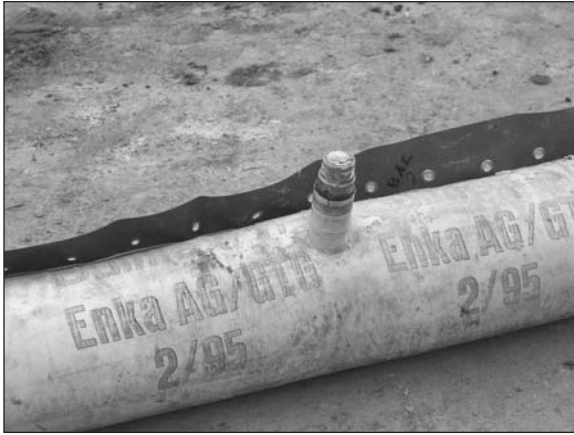
Figure 5. Inflatable grout bag

Stopping the water became the main priority on the project. TSKF successfully installed two steel rings affixed with inflatable grout bags, which created a bulkhead when the bags were inflated, as shown in Figures 5 and 6.

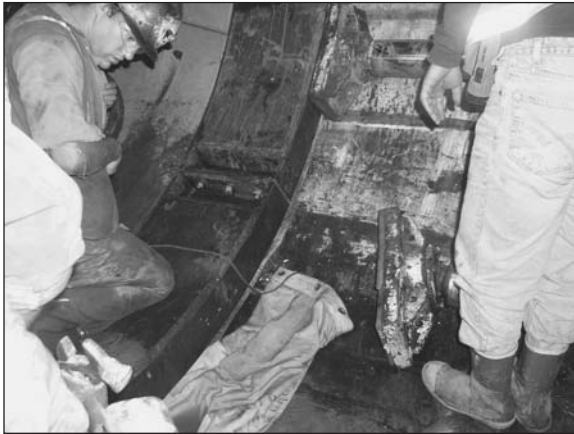
Figure 6. Installation of steel ring affixed with inflatable grout bags

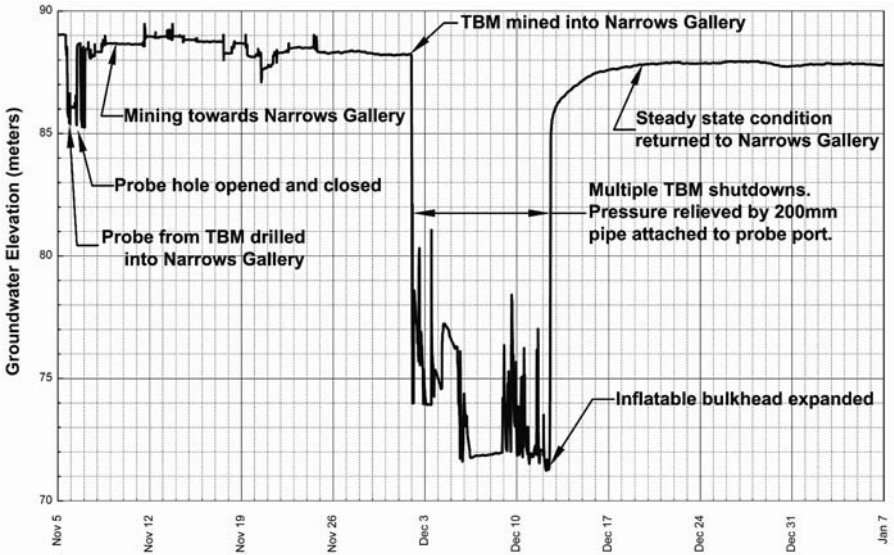
An instrumented observation well showed an instantaneous head drop of nearly 14 m when the TBM mined into the Narrows Gallery. When bulkheads were inflated on December 12, 2003, the piezometer showed a sudden increase in head of 12 m, and full recharge within 3 days. A plot of the piezometer's data is included as Figure 7. Once water stopped flowing from the probe port and from the cutterhead area, backfill grout was injected around the extrados of the segments all the way back to the Narrows Gallery. A differing site condition was granted to TSFK based on presence of silt material found inside the Narrows Gallery. Contract documents did not include any reference to any silt material inside the Narrows Gallery.

Figure 7. Observation well data
