# CONSTRUCTION OF A MIXED FACE REACH THROUGH GRANITIC ROCKS AND CONGLOMERATE

## ABSTRACT

The San Vicente Pipeline Tunnel Project involves the construction of an 8.5-foot-diameter water pipeline in an 11 mile tunnel in San Diego, California. The tunnel is located in extremely variable geologic conditions of strong granitic and volcanic rocks, weak sedimentary rocks, abrasive conglomerates, and mixed face conditions. One reach of the tunnel is a 5,200-foot mixed face reach that includes Friars Formation Conglomerate overlying granitic rock. Due to the variable ground conditions in this reach, the use of a TBM was deemed too risky and the contract documents required drill-and-blast and hand mining methods. Although it was not required, the contractor elected to construct this reach using NATM methods. This paper describes the geology of the 5,200-foot mixed-face reach, the design evaluation, and the construction challenges faced on this project.

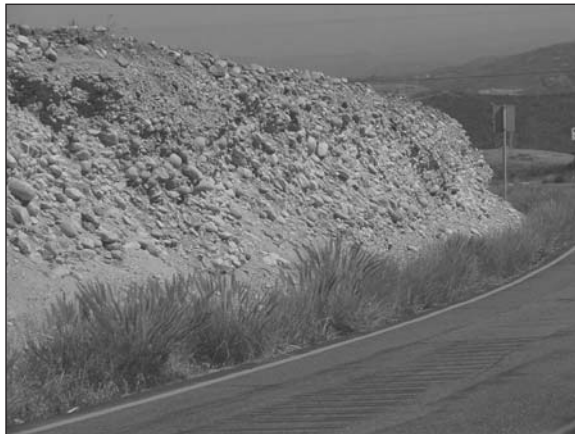
Figure 3. Conglomerate outcrop

The Friars Formation is part of the Eocene La Jolla Group, and conformably underlies the Stadium Conglomerate. It is horizontally bedded to gently dipping (less than about 20 degrees). The Friars Conglomerate consists of medium gray to grayish green, moderately indurated, matrix-supported gravel/cobble conglomerate with occasional boulders. Figure 3 is a photograph of an outcrop that illustrates the high cobble content of this formation. The matrix consists of silty to clayey sand, and the unit contains localized interbeds of sandstone and siltstone. Although it is generally uncemented, it is

weakly to strongly cemented in some places. Induration of this unit is due more to the tightly compacted matrix than to the degree of cementation.

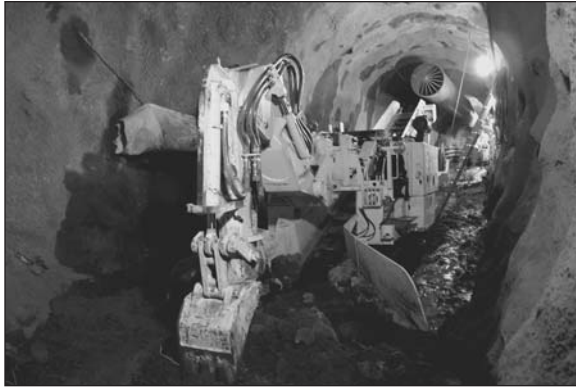
Figure 6. ITC 112 with E3S boom

allow personnel to witness pipe umbrella drilling and operation of an ITC tunnel excavator. Neither pipe umbrellas nor ITC tunnel excavators are in common use in the United States at this time, but the Joint Venture thought that these tools were well suited to the potentially unstable conglomerate and mixed face conditions below the water table. Based on the observations made during these trips, the Joint Venture decided to use an ITC excavator to dig the conglomerate sections of Reach R-5. They also prepared to procure the equipment necessary to install pipe umbrellas in case ground conditions warranted their use. An ITC is shown in Figure 6.

A used ITC 112 was purchased and refurbished at the Traylor Bros. Inc. shop in Evansville, Ind. ITC supplied a new E3S boom, which had the capability of tilting side-to-side in order to efficiently dig the horseshoe tunnel shape. Additionally, the travel system was upgraded so the ITC could tram quickly from one heading to another. Other equipment purchased to excavate and support the tunnel included: an Atlas Copco Rocket Boomer 282 drill jumbo equipped with Atlas Copco COP1838ME hydraulic drills to drill blast holes as well as drill probe holes, drain holes, and install pipe umbrellas; two Wagner ST3.5 LHDs and one Atlas Copco ST3.5 LHD to load and haul muck from the drill-and-blast sections; and two Dux DT12 8 cy tunnel trucks to haul muck in the highly weathered granite, conglomerate, and mixed face sections where the ITC 112 tunnel excavator was expected to be used. The LHDs loaded excavated material into a heavy-duty muck box in the shaft bottom. The muck box was hoisted by a Liebherr 883 crane. A robotic shotcrete arm was purchased from Shotcrete Technologies and mounted on a New Holland LS185 skid steer loader. The skid steer towed a trailer that carried a Schwing B310 shotcrete pump as well as the accelerator dosing system. A 5 cy Normet Transmixer was used to transport shotcrete to the heading.

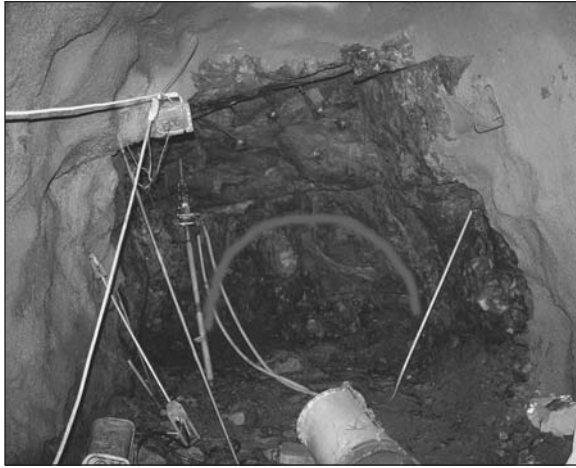
Figure 7. Excessive overbreak near rock-conglomerate interface

to support this section of tunnel. Ground conditions improved to the point where the ribs were no longer necessary and 6 foot Swellex rock dowels were adequate to support the rock. After 100 feet, the tunnel was necked down. It was taken from 16 feet, 6 inches wide by 14 feet tall to 10 feet, 6 inches wide by 11 feet, 2 inches tall. Drilling and blasting continued with 8-foot round lengths and rockbolt support for another 605 feet. The ground varied from slightly weathered granite with some spalling and loosening of blocks in the crown to fresh granite where no spalling was exhibited. When Reach R-5 East had advanced 605 feet, groundwater inflows began to increase, with several small flows from the face and sidewall. Up to this point, groundwater inflow had been limited to dripping in the crown and sidewall that lessened to nothing a week or so after the heading had advanced. A large block that fell out of the sidewall during blasting operations at this location is shown on Figure 7.

As the observed ground conditions became more adverse, the support classification was changed from 1.1 to 2.2 and the round length was shortened to 5 feet. Mining continued without incident for another 44 feet, at which point the first conglomerate was seen in the heading. The conglomerate was exposed in an approximately one foot square patch of the face near the crown. Though it appeared stable, there was a steady flow of water (estimated to be 15 gpm) dripping and streaming from the crown. The granite in the vicinity was weathered, but not disintegrated. Probe holes drilled in the heading did not show a significant weakness in the ground conditions, so it was decided to drill and shoot another round. The support classification was changed to 3.1 and the round length further shortened to 4 feet. Several more rounds were shot, fully exposing the conglomerate in the crown. There were no large boulders present and the ground exhibited good stand up time, with the heading once being left open for six hours with no raveling. The heading advanced 23 feet more with conglomerate in the crown until the face once again returned to rock. It was likely that the transition between rock and conglomerate was not far away, so mining continued with short rounds, though the support class was changed to 2.2. Conglomerate in the heading returned after approximately 46 feet of mining and the support class was again increased to 3.1 and the round length reduced to 4 feet. It was decided to continue blasting operations rather than to try to dig the conglomerate with the ITC tunnel excavator because, at the time, the conglomerate was difficult to dig and a majority of the

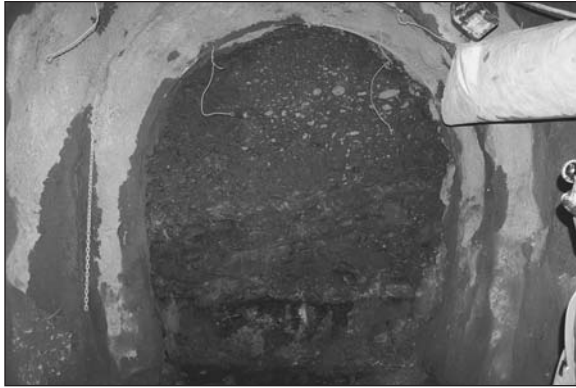
**Figure 8. Mixed face condition**

face consisted of granite. The proportion of conglomerate in the face continued to increase until on any given round it accounted for 45% to 55% of the face area, with the remaining face area being moderately weathered to slightly weathered granite. Figure 8 shows the mixed face condition, depicting three distinct layers of ground: weathered granite on the bottom, boulder-sized conglomerate in the middle, and cobble-sized conglomerate near the crown.

This roughly half-and-half mixed face condition continued for approximately 725 feet, after which the granite interface dipped down and conglomerate accounted for the full face area. An attempt was made to use the ITC 112 excavator to mine the conglomerate, but it was unable to do much more than scratch the face, and so blasting operations were continued. The inability of the excavator to dig the conglomerate was attributed to the density and cementation of the matrix and the tightly packed nature of the clasts within the matrix. After it became apparent that the conglomerate was relatively stable, the round length was increased to 5 feet with favorable results. Overbreak was limited and the conglomerate rarely raveled. One notable exception was a weakly cemented sand lens encountered in the crown for a length of approximately 20 feet. The sand was slow raveling and continuously dripped water, which resulted in difficulties related to shotcrete adhesion. This problem was remedied by drilling and installing 10-foot-long rebar spiles in advance of the excavation.
