Precast Concrete – A Unique Application

Sikorsky Bridge, Stratford, Connecticut

By William J. Frank, P.E., Murali Hariharan, P.E. and Jeff Wood

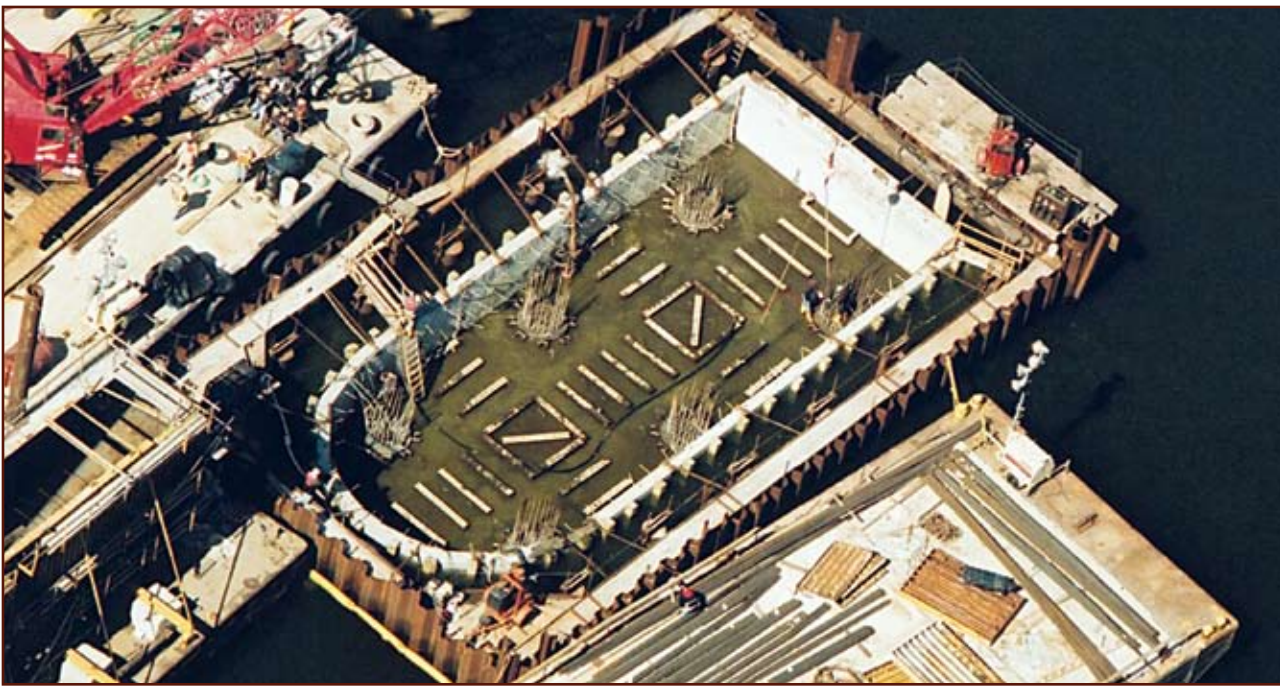
Figure 5: Precast Bathtub Nearly Complete. Courtesy of Morgan Kaolian/Aero, Inc.

Figure 5 (page 37) shows the completed bathtub for Stage 1. During dewatering, the seals held, the slab worked as anticipated, and the welded uplift restraints functioned as designed. The precast cofferdam remained dewatered for approximately a

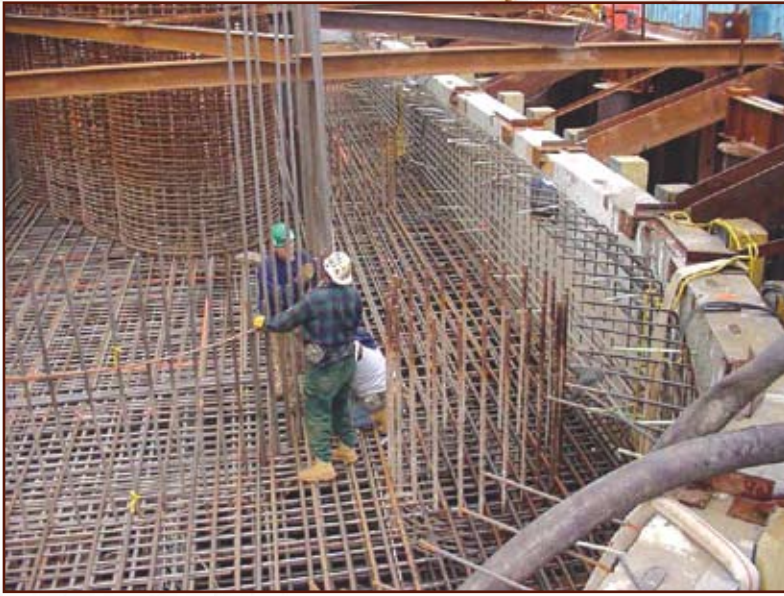
Figure 6: Rebar Installation Inside the Bathtub. Courtesy of William J. Frank, P.E.

month to permit rebar installation and, ultimately, the pouring of the footing concrete in early April 2003. Figure 6 shows the pier rebar installation inside the dewatered bathtub. The Stage 1 portion of the bridge was completed and opened to traffic in November 2003.
