Raw Water Tunnel Condition Assessment

ABSTRACT: As part of its risk management plan, the South Central Connecticut Regional Water Authority (RWA) is assessing the condition of its system of raw water conveyance tunnels and connecting pipelines. In 2006, the RWA inspected one of the system's main tunnels, a 4-mi, 1950s-era tunnel that had not been inspected since its construction. The inspection team prepared extensively for the unknown conditions in the tunnel, and the inspection was completed safely and successfully. This paper describes the team's pre-entry preparations, dewatering and ventilation efforts, surface-to-tunnel communication, access, physical inspection of the tunnel, and the lessons learned throughout the process. Additionally, this paper will preview planning for the subsequent inspections.

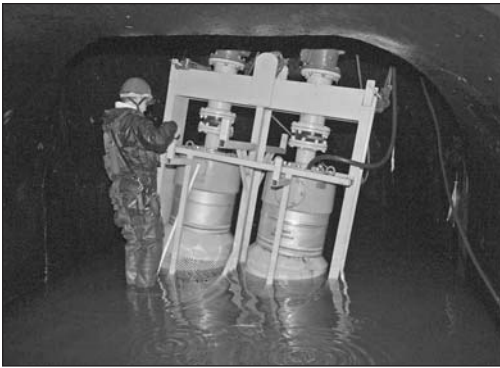
Figure 5. Dewatering pumps at the base of the working shaft

60 feet of submergence. The dewatering plan included a two-stage dewatering operation for pumping out the stored water. The pumps were first lowered to El. +160, the initial dewatering elevation. Once dewatering at this elevation was accomplished, the pumps were lowered to the invert of the tunnel without concern for breaching the electrical seals. The pumping system worked well to dewater the tunnel and maintain the low water level required throughout the inspection. During the inspection, the pumps were run for 10 minutes every hour to maintain a low water level at the Working Shaft. Figure 5 shows the pumps at the base of the Working Shaft between active pump-out cycles.
